TECHNICAL NOTE 2632

CORROSION OF MAGNESIUM ALLOY ZK60A IN
MARINE ATMOSPHERE AND TIDEWATER

By Fred M. Reinhart

National Bureau of Standards

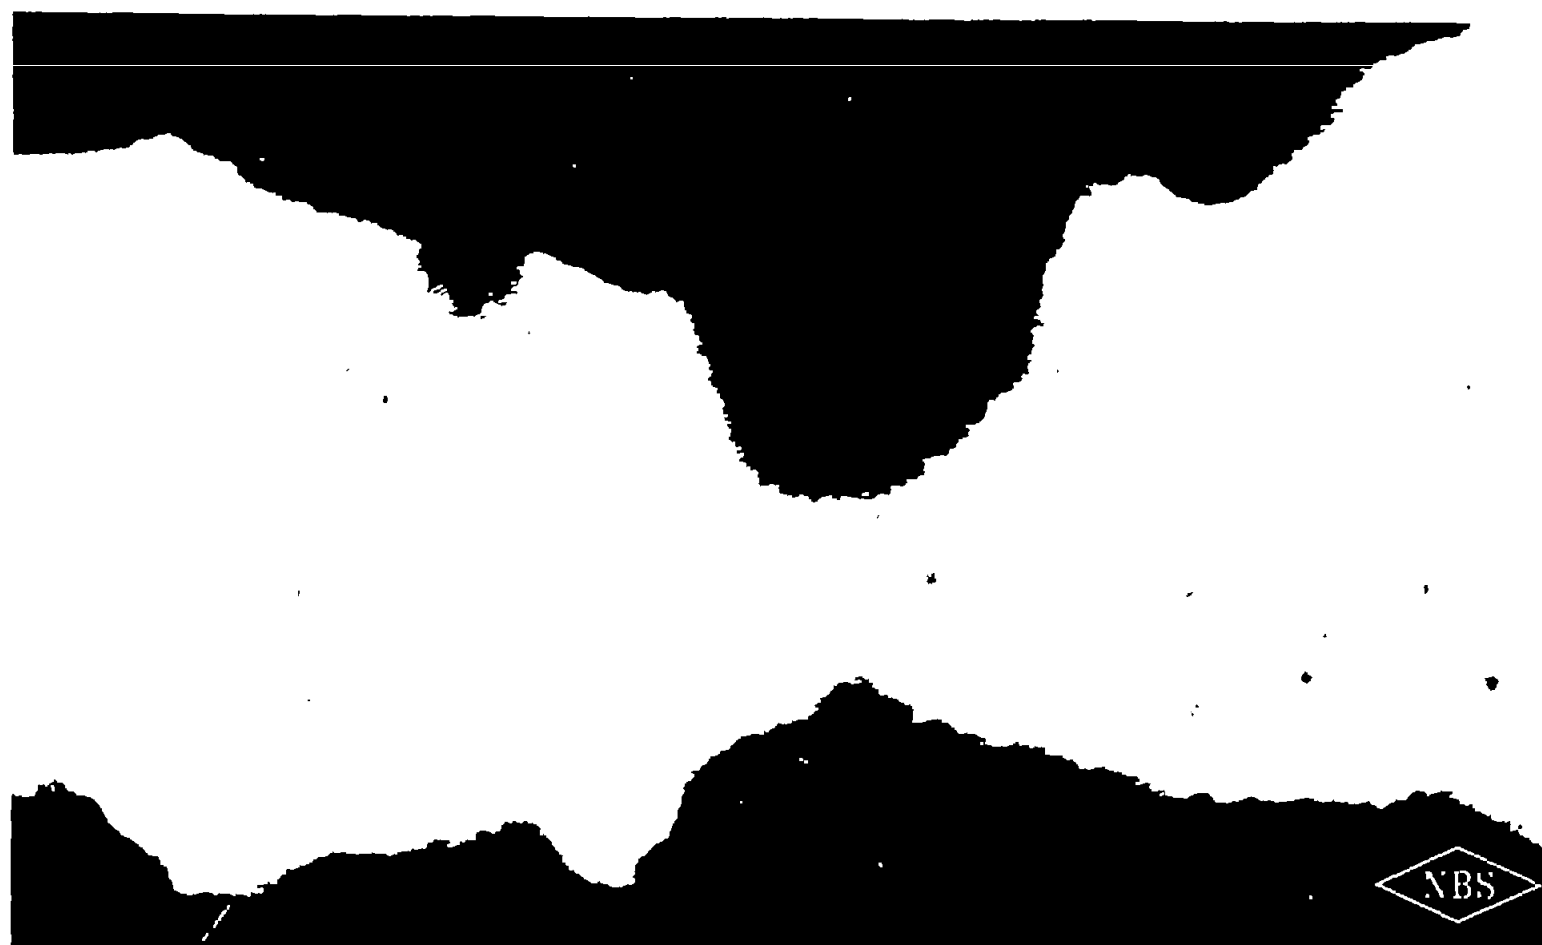
A typical example of the pitting of the ZK60A specimens and the minimum thickness of metal remaining after exposure in the tidewater is shown in figure 2.

It is difficult to make direct comparisons in depths of pits because of the extremely deep pitting and roughened surface of the ZK60A alloy. However, it is apparent from the values in table 2 and from figure 2 that the attack on this alloy was very rapid and severe, considerably more so than that on the AZ31A-H alloy.

Figure 2.- Cross section of specimen of ZK60A alloy showing type of pitting and minimum thickness of remaining metal after exposure in tidewater for 6 months. X100.

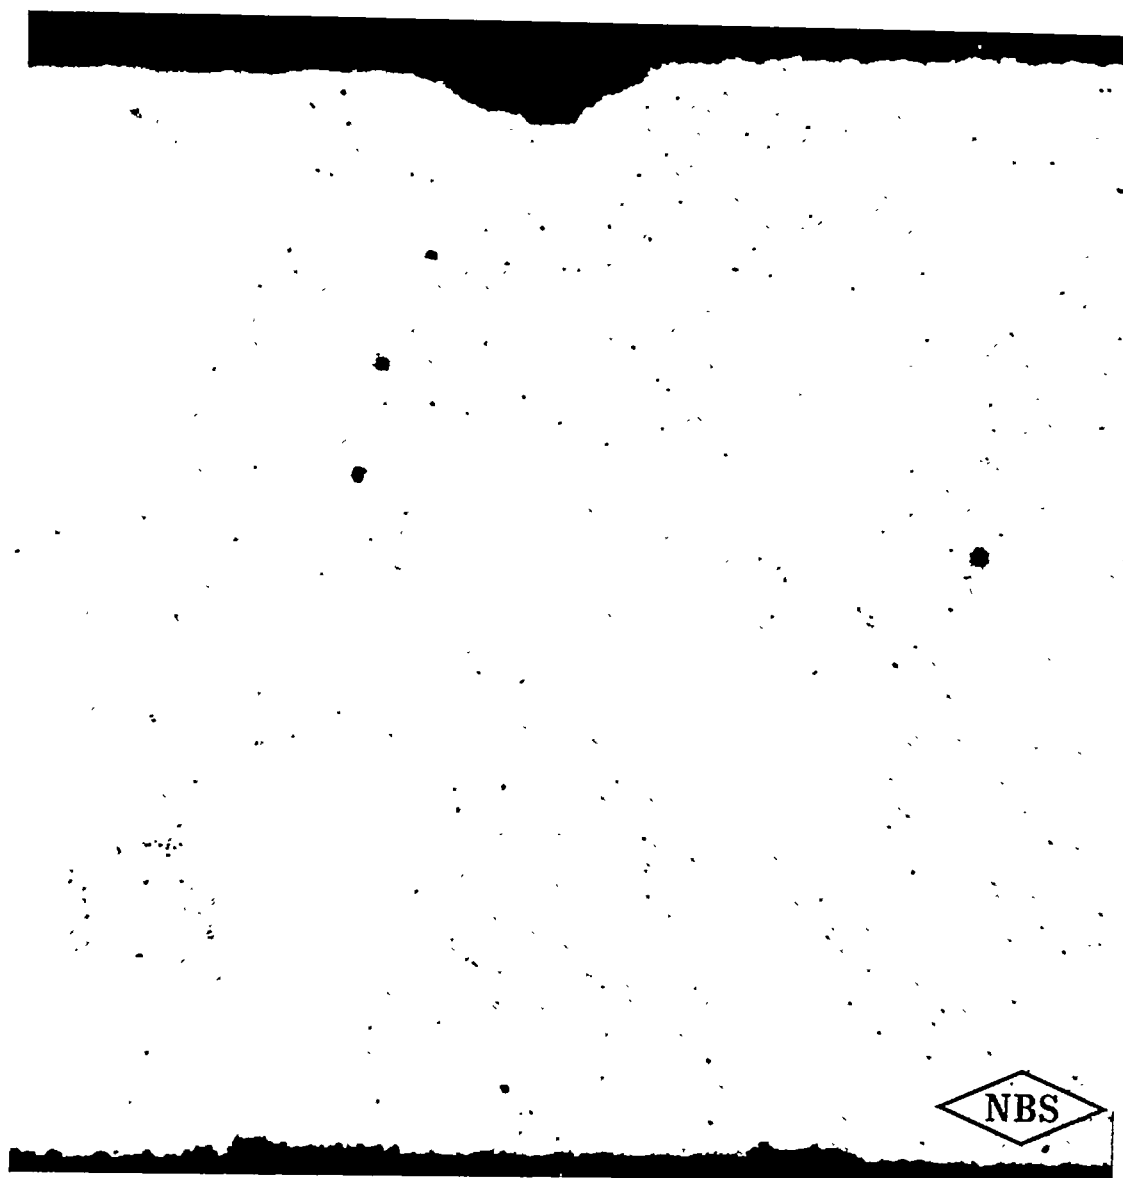
These results indicate that after 6 months of exposure the corrosion pits in the ZK60A alloy were deeper and wider than those in the AZ31A-H alloy. Typical corrosion pits in the ZK60A alloy after 6 months of exposure are shown in figure 3. An idea of the difference in the rapidity of attack between exposure in tidewater and in marine atmosphere can be obtained by comparing the thickness of the remaining metal in figure 2 with that in figure 3.

Figure 3.- Typical pits in ZK60A material after 6 months of exposure in marine atmosphere. Compare thickness of this sheet with that of one in figure 2. X100.

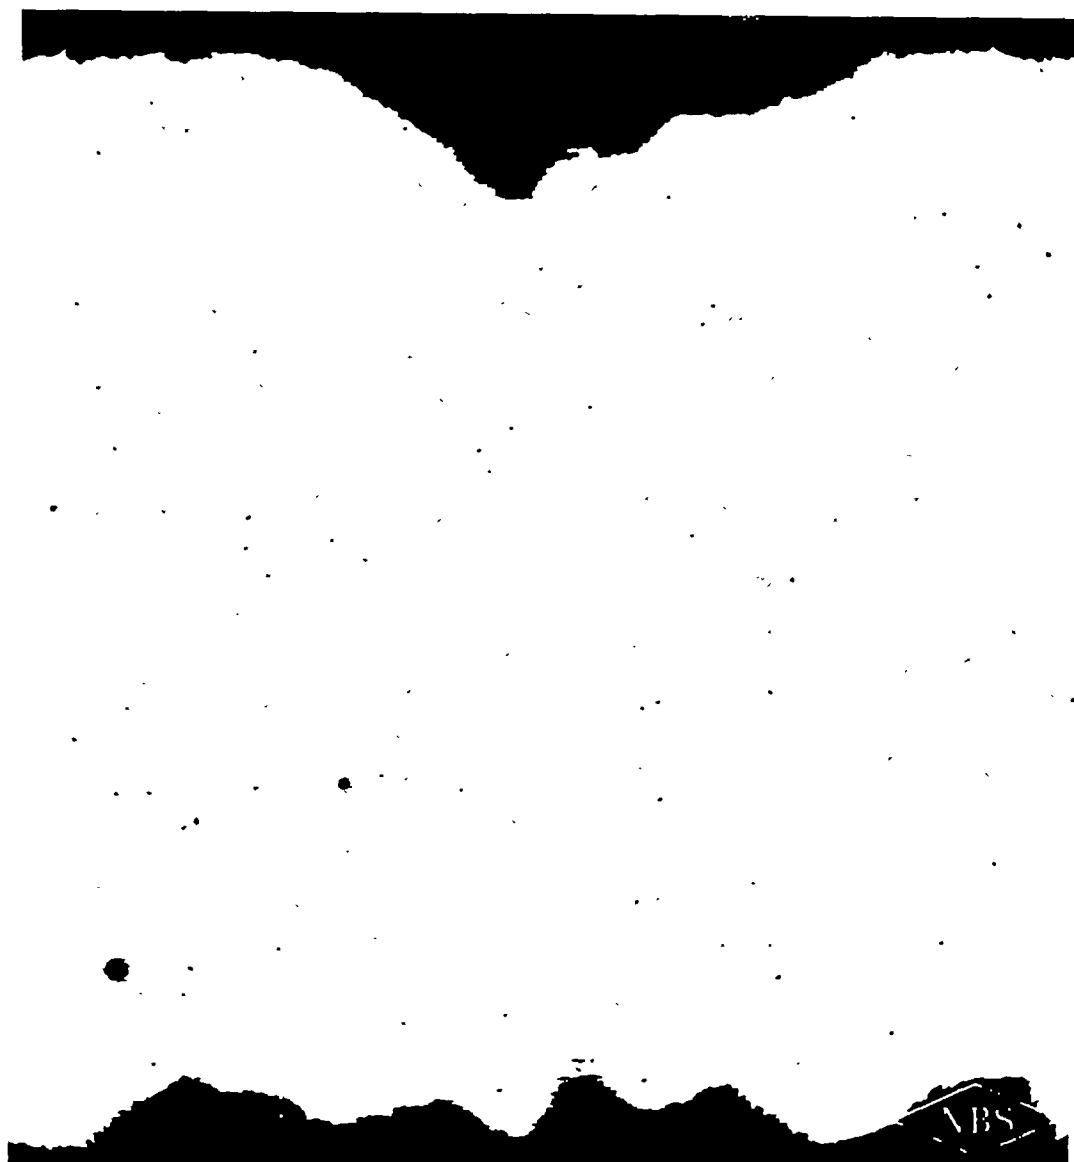
During the next 12 months of exposure, the rate of penetration of the ZK60A alloy decreased but the width of pits increased indicating that the localized attack was becoming less and the general attack was

more prevalent. Typical pits in this alloy after 18 months of exposure are shown in figure 4. No comparison could be made with the AZ31A-H alloy because no specimens of the latter alloy were removed at that time.

Figure 4.- Typical pits in ZK60A material after 18 months of exposure in marine atmosphere. Compare thickness of this sheet with that of one in figure 2. X100.
